Enhancing Yukon trade corridor resilience to northern geohazards

Overview of winter hydrology geohazards and icing mitigation strategies | Overview Report | August 2024

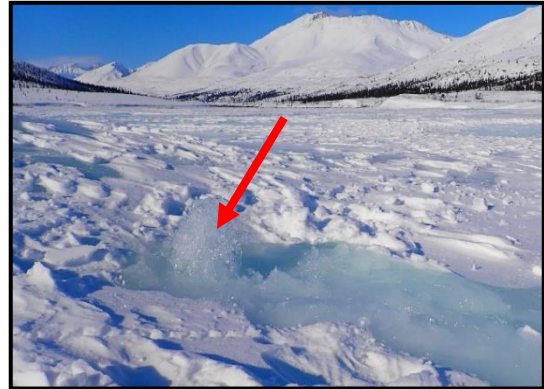
Figure 3. Pressure-driven overflow through an augered hole at km 72 on the Dempster highway on Apr 4, 2024.

Spring augering: The late-winter/spring perforation of an aufeis body comprising unfrozen or porous layers may help direct spring runoff from the ice surface back to the stream bed and through a culvert. Once drainage through these small holes is established, the runoff can further melt and erode the holes, developing well-established sub-surface drainage pathways in the following weeks and attenuating the flood potential upstream of culverts (**Error! Reference source not found.**).

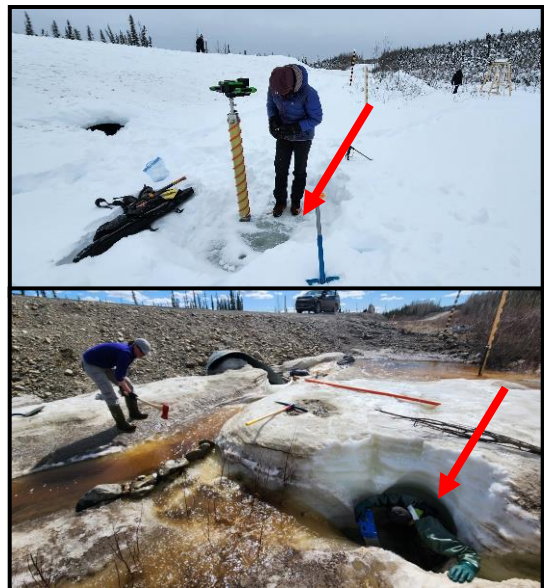
Figure 4. location of an augered hole at km 32.6 on the Dempster highway in March 2023 (top) and the expansion of this drainage hole by early May 2023 (bottom).

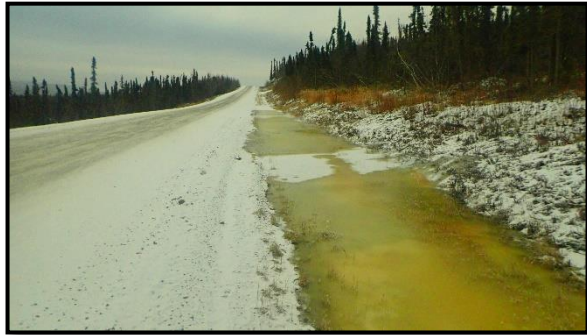
Figure 6. Groundwater-induced icing near km 29 on October 28, 2022.

In years where groundwater discharge remains high throughout the winter (i.e., after a wet fall), extensive icing occurs, originating from the highway's left or west side (upslope). In most cases, this discharge seeps into the ditch, causing icing along hundreds of metres along the road. Seven discrete areas of icing were observed in winter 2022-2023 between Km 16 to 32 for a total of 1.8 km of affected highway, but the most intense groundwater seepage site is located close to km 29. Culverts within these active icing zones quickly become plugged with ice, causing drainage problems in the spring, if not before.

- Blockage of targeted culverts in the fall
- *Investigation of historical upslope groundwater disturbance*
- *Frost belts upslope of highway
- *Thermosyphons upslope of highway
- *Groundwater drainage or dewatering

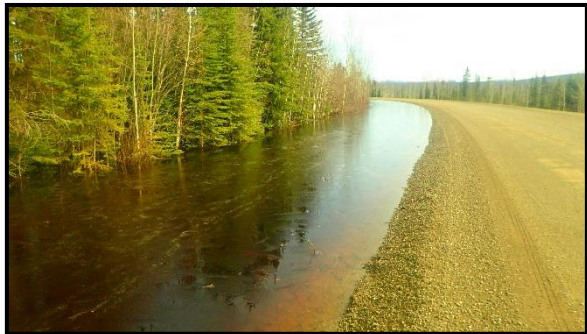
Figure 7. Water ponding on the upslope of the Dempster Highway near km 29 on May 9, 2023.

The lower section of the Dempster Highway passes across the southern foot of the Ogilvie Mountains. There is active groundwater discharge within this region, potentially because of surface and subsurface disturbances on the hillside above the highway (with permafrost's possible and unconfirmed presence).

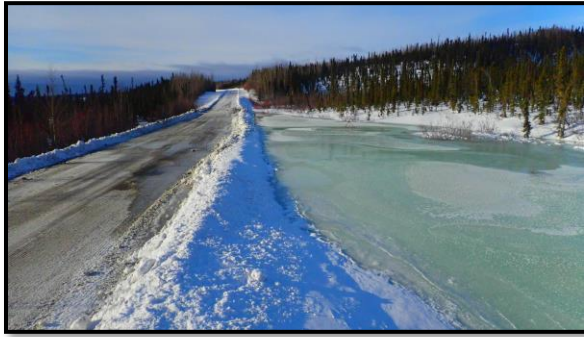
Figure 9. Unnamed Creek (km 32.6) wetland on March 24, 2022.

- Removal of decommissioned steam pipes and heat tapes
- Blockage of culvert #3 with inflatable device
- Snow damming of auxiliary culvert #5
- Reduction of generator operation time
- Solar panel energy source for heat tape
- Spring drilling in front of main culvert #4
- Snow management (protect culvert outlet against snow accumulation)

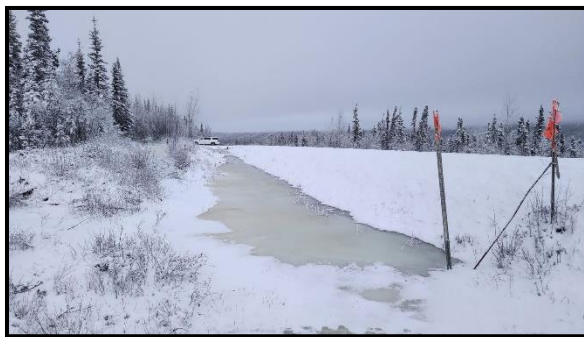
Figure 11. Unnamed Creek (km 33.8) culvert head and ditch on Dec 9, 2022.

A stream drains a wetland complex that lies north of the highway. The stream reaches the highway at km 33.8 at an angle through an artificial ditch. During winter, the ditch fills with aufeis, and a depression in the berm enables overflow to reach a secondary culvert at km 33.9. A heat tape is installed at that secondary location (the culvert is damaged and needs to be replaced) to guide overflow to the culvert. Unfortunately, this mitigation is only partially successful.

- Addition of an auxiliary culvert made of plastic (currently being considered with HPW-TMB)
- Reduction of generator operation time
- Solar panel energy source for heat tape
- Improvement of surface drainage to auxiliary culvert
- Snow management

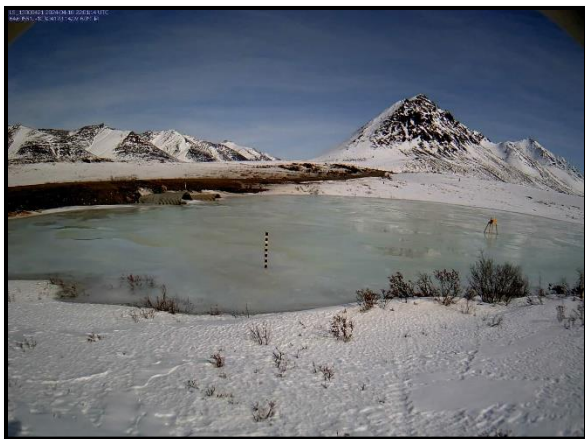
Figure 18. Timelapse photo of East Blackstone River culvert head on Apr 18, 2024.

The East Blackstone River headwaters lie in the Ogilvie Mountains. The river drains several alpine valleys through a permafrost-rich lowland that parallels the Dempster Highway from ~km 80 – km 85.9, where it crosses the road through two large (Ø 4.5 m) structural culverts. The East Blackstone River continues to parallel the highway downstream of the crossing until it reaches the Blackstone River near km 115. Aufeis routinely forms upstream and downstream (down to km 88) of the culverts (Figure 17/Figure 18), causing drainage concerns across the road before and during snowmelt. Aufeis also forms on the river surface at other locations along the East Blackstone River. However, it only seems to represent an immediate road infrastructure or safety hazard between km 85.9 and km 87.5. High winds and wind-blown snow play a role in forming this aufeis.

- Snow management (removal from culverts, snow dams upstream of culverts during mid-winter period)
- Late-winter ice surface darkening
- Heat sources fed by solar panels
- Replace culverts by a bridge or move crossing to another location

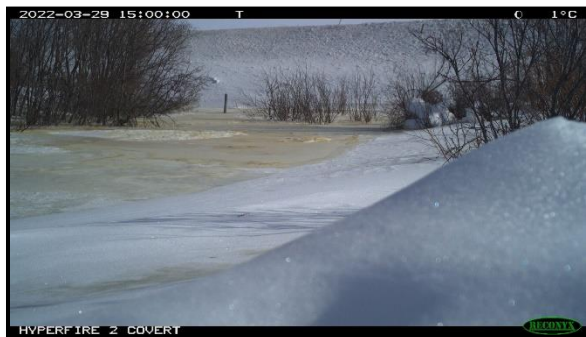
Figure 20. Slavin Creek (km 98.6) timelapse photo of culvert head buried by aufeis on March 29, 2021 (Photo provided by McMaster University, Sean Carey’s research team).

A groundwater-fed creek drains through permafrost-rich tundra west of the highway at km 98.6. The creek crosses the highway through a single culvert which downstream end is hanging above a relatively deep pool. Aufeis plugs the culvert at this site each winter, affecting a large area immediately upstream of the culvert during the spring. The permanent steaming pipe has apparently been damaged and has not been replaced. Blockage begins during the first cold nights and usually reaches 100% before the end of winter. The thickness of this aufeis is likely limited to 2 m, either because of low winter water supply or by the porous nature of the lower road embankment. However, the spring overflow can be many meters deep.

- Early observation and assessment of ice conditions
- Solar panel energy source and new heat tape
- *Ice drilling from downstream end of culvert
- Installation of an auxiliary culvert at higher elevation to carry snowmelt runoff

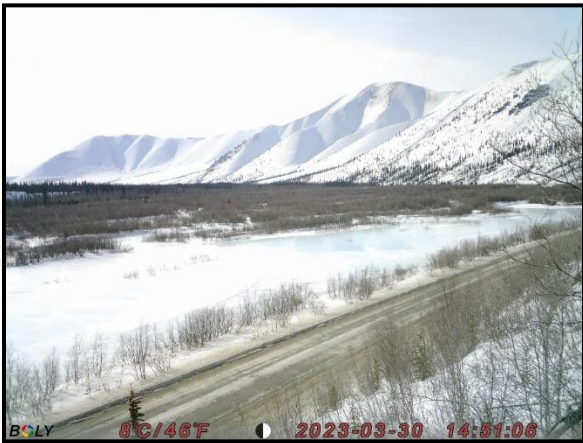
Figure 22. Timelapse photo of Blackstone River at km 143.7 on March 30, 2023.

The Blackstone River flows parallel and generally some distance from the highway until km 145.6, where the highway turns west into Windy Pass. Between km 142 and 144, riprap has been installed to protect the road against erosion. The Blackstone River develops aufeis on its surface at many locations, including along that segment. Aufeis commonly achieve a thickness of more than 2 m near km 143, and this probably represents a higher flood risk than high open water flow conditions. This aufeis can damage riparian vegetation and rip rap. Ice blisters have been observed in recent winters, confirming that winter flow conditions can be pressurized.

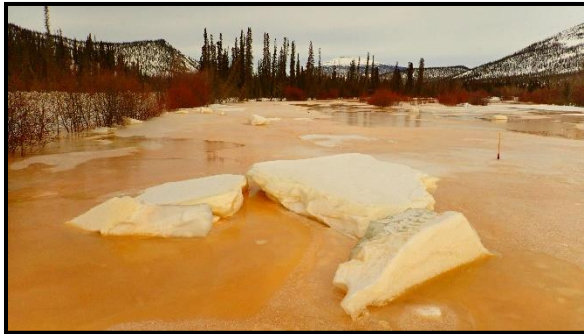
Figure 24. New (colored) overflow and aufeis along Engineer Creek near km 173 on April 3, 2024.

Engineer Creek is a sediment-rich and iron-rich (orange) creek that drains from the south and reaches the Dempster Highway at km 160.6. It crosses the highway at this location and then flows parallel to the highway until km 195. Engineer Creek is highly streams susceptible to erosion processes but also experiences river aufeis (Figure 24) and flooding, just like several other streams such as Red Creek (km 168.2) that cross the Dempster Highway in that area. Engineer Creek flows immediately beside the road embankment at many locations, exposing it to water-related hazards in all seasons. Stream crossings at km 160.6 (Engineer Creek, Figure 23) and km 168.2 (Red Creek) comprise large culverts that seem to initiate and promote aufeis development.

- Monitoring and early-observation of aufeis development at stream crossings (e.g., km 168.2)
- Solar panel energy source and new heat tape (km 160.7, km 168.2)
- Snow management (removal from culverts, snow dams upstream of culverts at km 168.2)
- Replacement of culverts by a bridge (km 160.7)

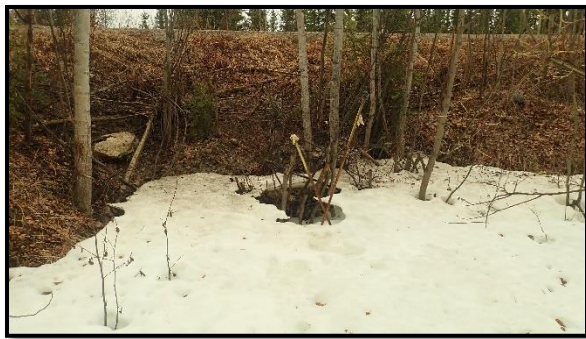
Figure 27. Gochis Creek after the partial melt of a 1.5 m-thick aufeis in May 2022.

Gochis Creek drains north to south into the Stewart River, intercepting the Silver Trail at km 3.9. Stream aufeis develops upstream of the Trail and can entirely plug one of the culverts, as observed during winters 2021-2022 and 2023-2024. The steam pipes at the culvert heads contribute to intercepting debris, preventing optimal drainage and potentially promoting a complete blockage by ice. In most years, the creek may carry enough groundwater heat to continue flowing under an ice cover without causing overflow events. However, this condition is only achieved under specific winter weather sequences and could be supported by accessible, low-energy interventions. Aufeis at this location may be initiated downstream of the culvert, which influences mitigation strategies.

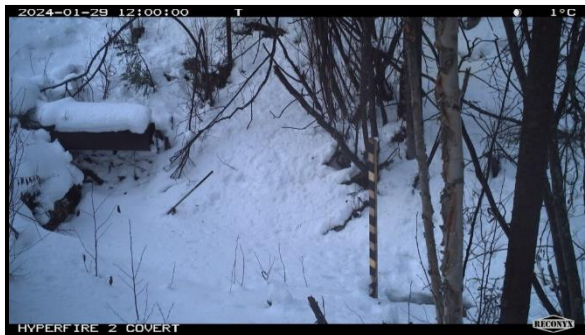
Figure 29. Timelapse camera photo of Unnamed Creek (km 17.1) on Jan 29, 2024.

An unnamed creek drains from the northwest and intercepts the Silver Trail in a relatively deep canyon at km 17.1, where it drains through a damaged (capacity reduction of about 20%) primary culvert. Though stream-fed aufeis filled the lower part of this canyon in winter 2021-2022, no significant aufeis developed in winter 2022-2023 or 2023-2024. As stated for km 3.9, and as high-resolution data revealed, the creek carries enough heat to maintain an under-ice flow throughout the cold season without producing overflow events and aufeis under most early and mid-winter weather scenarios. However, in years where overflow would occur, simple mitigation measures could resolve the issue.

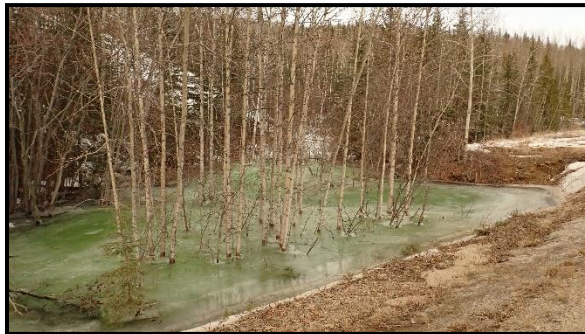
Figure 31. Photo of Lightning Creek with massive overflow on April 2, 2024.

Lightning Creek drains from the north and crosses the Silver Trail at km 23.1 through damaged (capacity reduction of about 20%) culverts before reaching farmland and, ultimately, the Stewart River. The creek was affected by aufeis formation upstream of the culverts during the winters of 2022-23 and 2023-24 (this is the opposite of what was observed at km 17.1). Both culverts were submerged by ice, suggesting that the staggered culvert mitigation strategy does not work efficiently. It seems that this creek may carry less heat than those located at km 3.9 and 17.1. At the end of winter 2023-2024, the high backwater on the upstream side of the Trail drowned the steam pipe heads and caused significant damage to the road embankment (closed lane for several weeks).

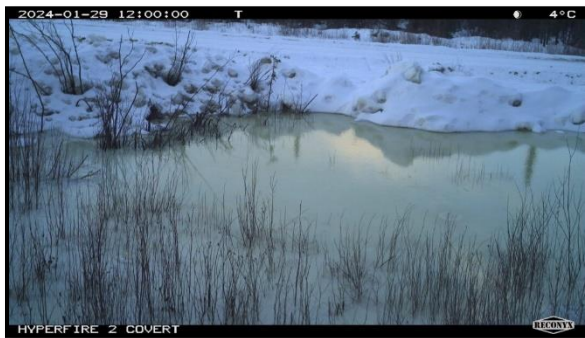
Figure 33. Timelapse photo of Glacier Hill Creek (km 60.1) culvert heads on Jan 1, 2024.

Glacier Hill Creek drains from the east in an area referred to as “glacier hill,” reaching the Silver Trail at km 60.1. The site, a low-gradient wetland, has developed significant augeis in the past (as stated by HPW personnel), including during the winters of 2022-23 and 2023-24. The culvert seems to be responsible for this situation. Additional overflow soon compromises road safety, requiring frequent ice removal and steaming. Repairs to the road embankment along the culvert have also been required. In the spring of 2023, snowmelt overflow was carried by the east ditch to km 61.4, flooding segments of the eastbound lane. Fine sedimentation also seems to represent a challenge to mitigate.

- Installation of a short heat tape operated as needed
- *Snow insulation was proposed by HPW personnel, and this could be tested. If not successful, a snow berm could be built to temporarily control overflow.
- Installation of heat tape connected to the grid or to solar panels (in the spring) and operated as needed
- *Heat tape and wood posts in the ditch from km 60 to km 60.3
- *Replacement of culvert by a small bridge and restoration of the Creek channel

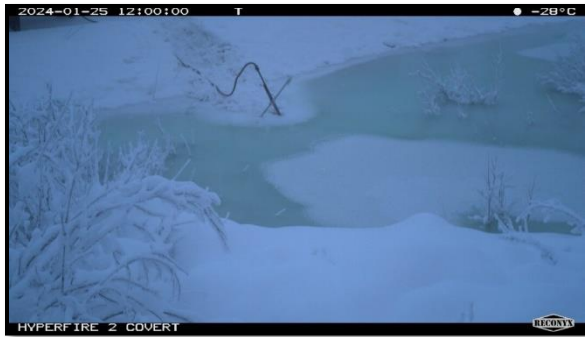
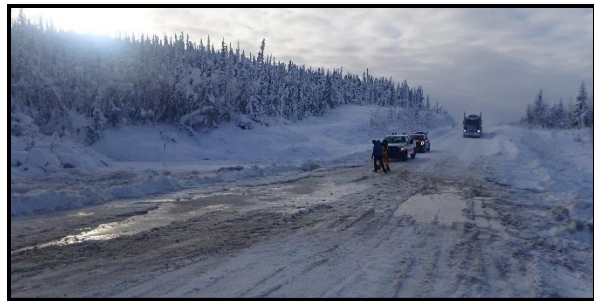
Figure 35. Timelapse camera photo of Unnamed Creek culvert head on Jan 25, 2024.

Figure 36. Overflow and glaciation on the Silver Trail at km 81.6 on Feb. 13, 2023.

A very shallow creek drains from the east, intercepting the Silver Trail at km 81.6. Many broken steam pipes encumber this site in the upstream ditch, and an excavator has damaged the culvert head. Significant stream-fed aufeis formed at this site during the last three winters of observation, resulting in a flooded and damaged road embankment (Figure 36). The culvert seems to be initiating and causing some of the aufeis. During the winter of 2023-2024, groundwater seepage from the right slope (when looking upstream) contributed to the development of a massive icing mount.

- Removal of all existing steam pipes as they probably contribute to aufeis development in the culvert
- Installation of a short heat tape operated as needed
- Installation of a vertical graded rod or pole at the head of the culvert
- *Rising the water depth upstream of the culvert and install wood posts to promote the early formation of an ice cover
- *Replacement of metal culvert by two plastic culverts, one to be entirely blocked at its upstream end each fall

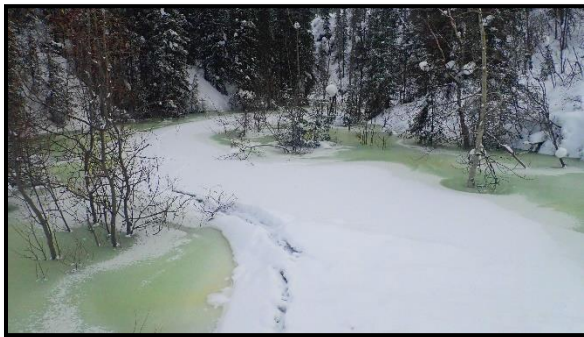
Figure 38. Photo of Corkery Creek with about 5 m of backwater on March 22, 2022.

- Improvement of snow management (reduce velocity of snowplows so that the snow does not block the culvert inlet)
- Extension of heat tape connector to improve accessibility from the road
- Connect heat tape to a generator or a solar panel (during later winter), as needed, when backwater is first observed
- Consider removing heat tape from steam pipe to reduce heat loss
- *Addition of an auxiliary culvert made of plastic at higher elevation
- *Prevent cold air from entering downstream end of culvert

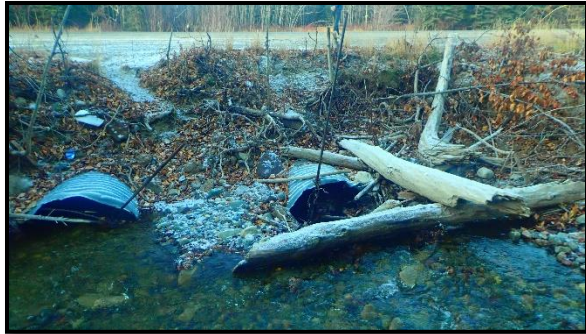
Figure 48. Head of three culverts in the Montague roadhouse rest area in October 2022 (culverts are mostly blocked by debris).

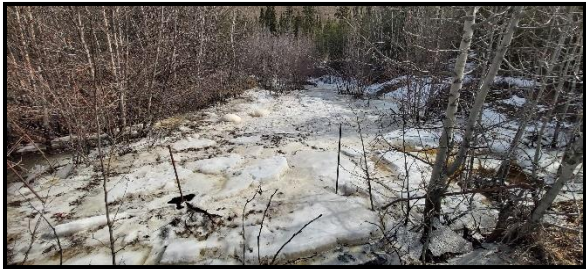
Figure 49. Same location as in Figure 45, but looking upstream, in May 2022 (creek is full of afeis, overflow was redirected in ditch to the next culvert located 1 km away).

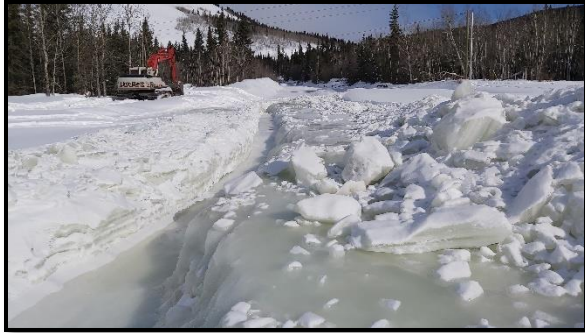
Figure 50. Ice excavation in March 2021 upstream of Jensen Creek culvert.

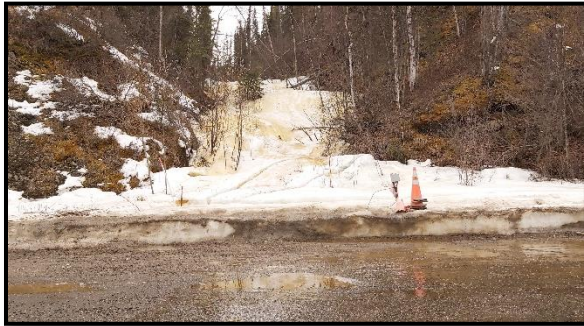
Figure 53. Frozen waterfall and massive aufeis accumulation upstream of North Klondike Highway on May 7, 2021.
